■ Case Report

Metal head fatigue fracture and coin like metal corpora libera in two cases. Is the reason -3 size head usage?

We report a very rare and extraordinary complication, metal head fatigue fracture at the site of the socket tip deep border and coin like metal corpora libera in two cases with metal on metal total hip prosthesis. Catastrophic wear at the site of the deep border of the collum socket and coin like loose body originating from the crom-cobalt head resulted with metallosis, osteolysis and failure. The outcomes of the revision operations were satisfactory and the patients returned to their daily activity without discomfort in their hip. Headwear is a well-known result of the metal on metal articulation and may present with instability, metallosis, pain and mechanical symptoms. These incidents might be important to investigate for tribological performance of hip implants in biotribology science. We believe -3 sized metal head usage might be the reason of this catastrophic complication their usage should be avoided in metal on metal arthroplasties.

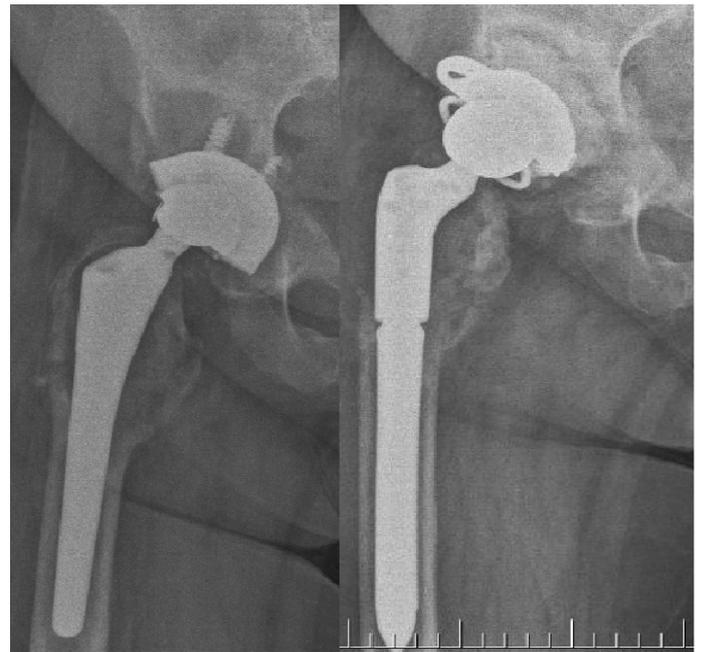
The patient was an active teacher. She weighed 56 kg and was 167 cm tall. Neurovascular system examination was normal. She had a positive trendelenburg sign and antalgic gait. Although her active flexion was limited to 80° with 0° of rotation, passive ROM was unrestricted but painful at the end of the range with the exception of external rotation. External rotation was limited to 5°. Approximately 1 cm lower limb discrepancy was determined. A result of complete blood count and biochemistry was within normal range, except slightly high white blood cells. Erythrocyte sedimentation rate was 32mm/h, whereas C-reactive protein level was 3,7 mg/dl. Serum chromium, cobalt, and molybdenum levels were 0.77 ng/mL, 0.24 µg/L and 1.20 µg/L, respectively. Preoperative radiographs revealed an uncemented THA with the metal head to be got thinner asymmetrically and deformed and an acetabular component with loosening and severe periprosthetic osteolysis. Periprosthetic osteolysis was also determined around the proximal part of the femoral component. (Figure 1)

Figure 1: Preoperative and postoperative radiographs of the Case 1 revealing periprosthetic osteolysis and asymmetric thinning of the metal femoral head, also metal corpora libera originating from the metal head is lying adjacent to the lateral border of the head.

During the revision THA procedure significant metallosis and both acetabular and proximal femoral osteolysis was detected. (Figure 2) Hypertrophic tissue containing metal debris was removed, and synovectomy was performed as complete as possible. When we dislocated the hip joint we observed that there was severe asymmetrical wearing of the metal head exposing the deep border of the collum socket tip, and a coin like loose body originating from the chromium-cobalt head fits to the deep borders of the flute of the head in which the neck of the femoral prosthesis is plugged. The coin like loose body was floating free adjacent to the head laterally as seen on the preoperative radiographs. (Figure 3) After removal of the metal insert and the screws, the metal shell was easily removed from the osteolytic acetabulum (Figure 2). Gross bone loss detected in acetabulum. Although grossly stable, because of the significant bone loss proximally around the femoral component femoral bone-ingrowth was considered to be ineligible. After the joint debrided and lavaged with a pulstabil lavage system (Zimmer®, Warsaw, IN), the acetabular component was revised to a 54 mm cemented constrained polyethylene liner (BIOMET®, USA) after grafting with 150 cc allograft and metal cage implantation. Also, femoral component was revised to a modular, fully porous coated revision system with excellent distal fixation (ARCOS, BIOMET®, USA) composed of a stem with 16

mm diameter and 150 mm length and a proximal component with 16 mm diameter and 70 mm length. A standard 36 mm metal head was inserted. The functional and the radiological results of the revision operation are satisfactory to date from the point of both the patient and us. The patient returned to her daily activity without discomfort in the hip.

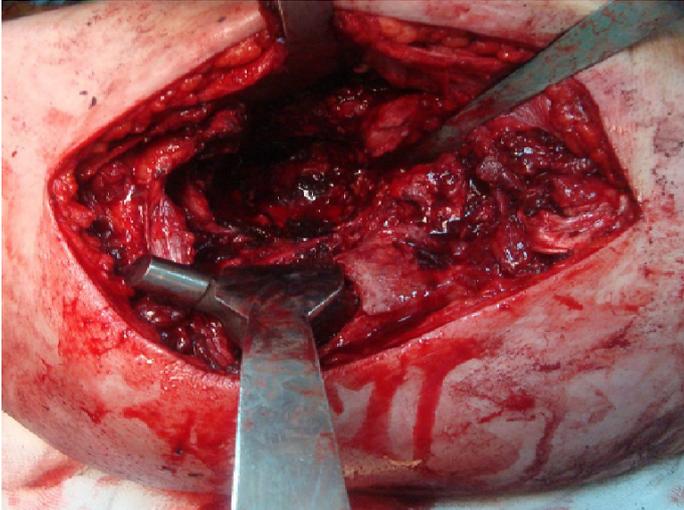
Figure 2: Intraoperative acetabular osteolysis and the metallosis.

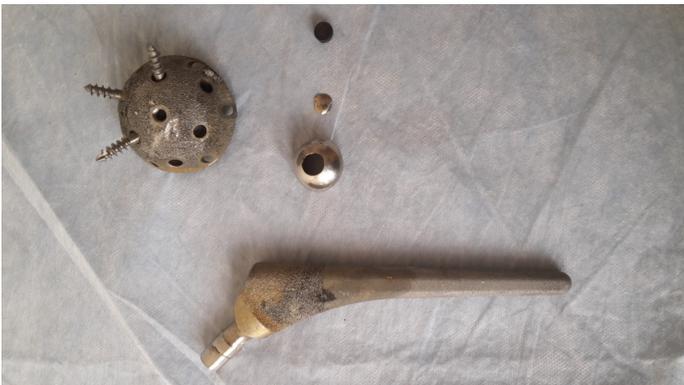
Figure 3: Asymmetrical wear of the metal head and the coin like free fragment originating from the head.

fracture of the metal head in a non-modular femoral implant through the weld, which is known to be the site of the metal weakness, in the literature. But, to our knowledge there is no report about the modular head fracture due to catastrophic wear at the site of the collar socket tip deep border. These two cases are the first report on this subject. In both cases thinner head structure between the articular surface and the collar socket tip deep border associated with the implantation of -3 sized head and high activity level of the patients may be the probable cause of the head dissociation.

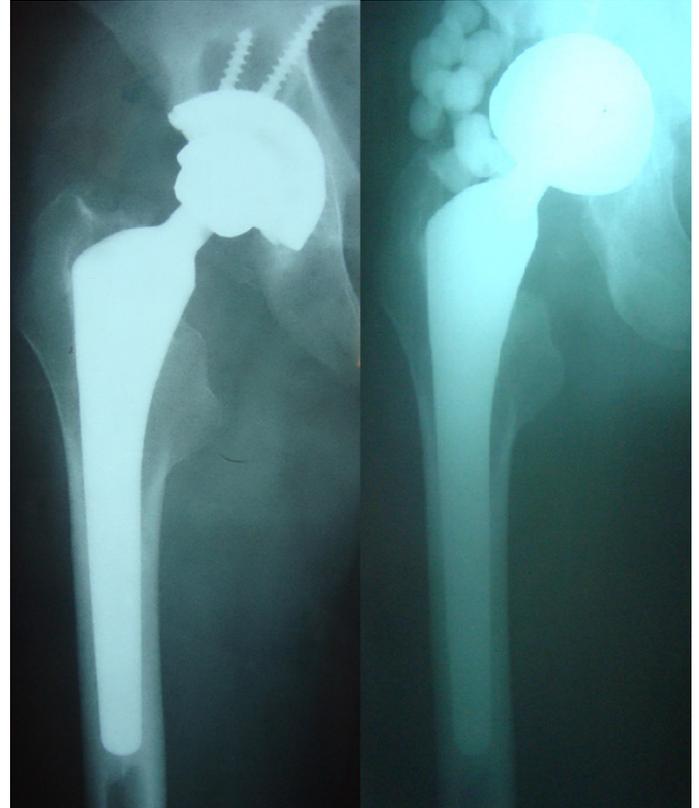
was within normal range. Erythrocyte sedimentation rate was 13mm/h, whereas C-reactive protein level was 2,6 mg/dl. Serum chromium, cobalt, and molybdenum levels were 0.57 ng/mL, 0.34 µg/L and 1.76 µg/L, respectively. Preoperative radiographs revealed an uncemented THA with severe perioperative osteolysis around the acetabular component. (Figure 4)

Figure 4: Preoperative and postoperative radiographs of the Case II revealing periprosthetic osteolysis.

During the revision THA procedure significant metallosis and peri-acetabular osteolysis was detected. Hypertrophic tissue containing metal debris and the synovium were removed. When we dislocated the hip joint we observed the dissociation of the metal head exposing the deep border of the colum socket tip, and a coin like loose body originating from the crom-cobalt head fits to the deep borders of the flute of the head in which the neck of the femoral prosthesis is plugged. The coin like loose body was residing in the deep space of the flute of the metal head. (Figure 5). After the removal of the acetabular component, joint debrided and lavaged, the femoral head was revised to a 56 mm bipolar head (BIOMET®, USA). The functional and the radiological results of the revision operation are satisfactory to date from the point of both the patient and us. The patient returned to her daily activity without discomfort in the hip.

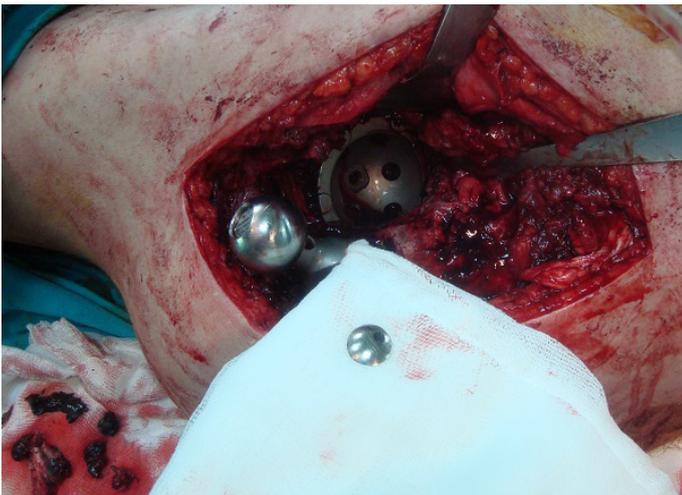
Figure 5: Intraoperative view of the metallozsis, the dissociation of the metal head and the coin like free fragment originating from the head.
